# Ameristar Impasse II Palisade Fence Test Report

## Executive Summary

## Objectives

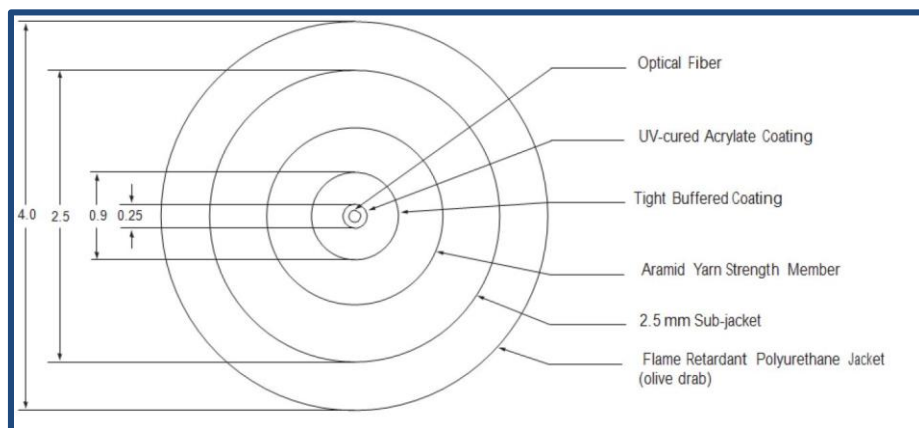
Figure 2: SC-4, 4mm Sensor Cable. Dimensions are in mm

SC-4, in Figure 2, is also a tight buffered cable but has an additional 4mm jacket for protection.

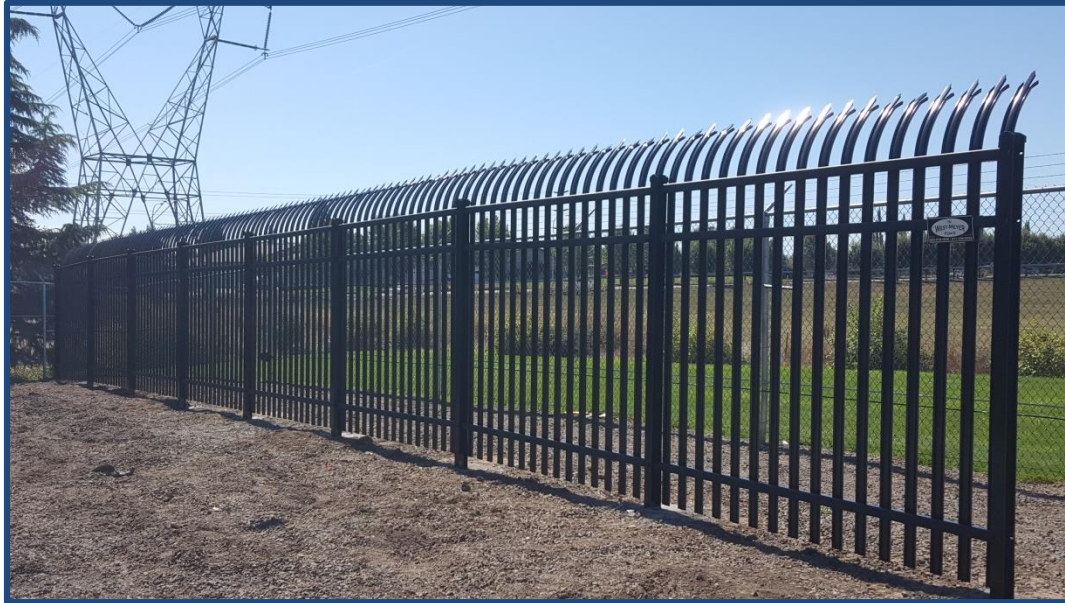
Figure 3: 64 ft. Ameristar Impasse II Fence

At Fiber SenSys headquarters in Hillsboro, Oregon, USA, eight panels of Ameristar Impasse II fence were erected for a linear length of 64 feet in our demo yard.

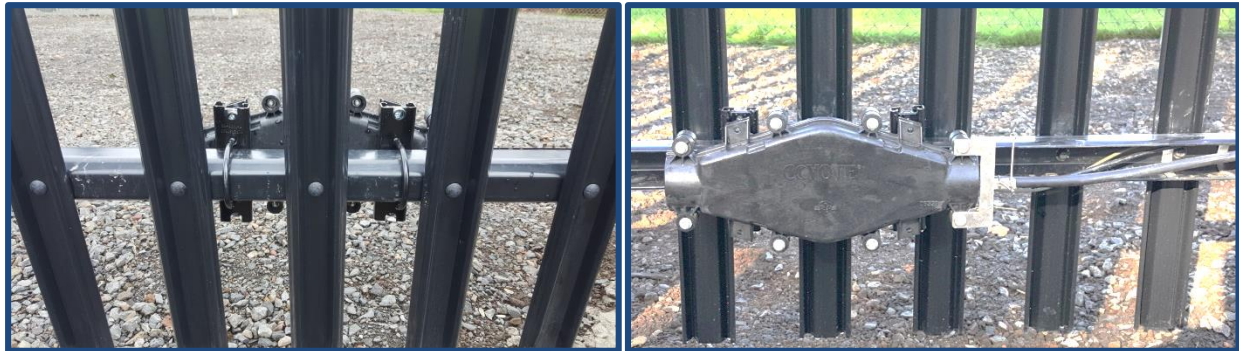
Figure 4: Mounting the 2ZB-525 Breakout Box to Bottom Rail

After the fence was constructed SM-06 was spliced into a backbone cable connected to an existing DB32 (distribution box) installed in the demo yard. The SM-06 was run from a vault through a conduit sweep that exited directly into the bottom rail of the fence until the middle post (32 feet) where a 2ZB-525 breakout box was mounted using a combination of channel strut, U-bolts, and miscellaneous hardware.

The mounting hardware components were painted black to match the fence which resulted in a much lower visual impact. In addition to improved aesthetics, it causes a potential intruder to be less likely to notice the breakout box.

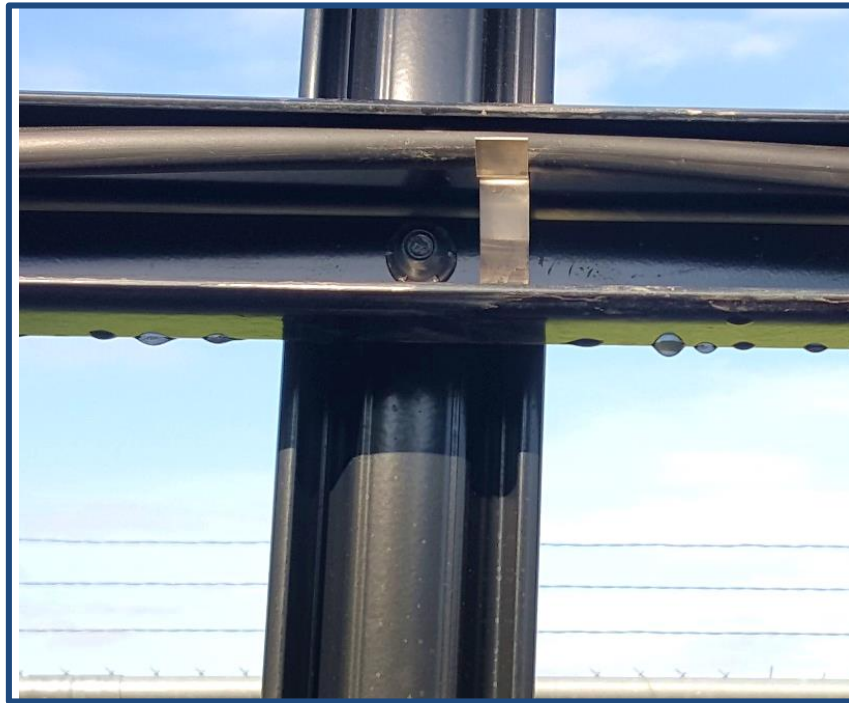
Figure 5: Sensor Wire Clips (SWC100) Securing SC-4 and SC3-C

Next, both sensors were routed along the top and bottom rails. Every 12" each sensor, SC3-C and SC-4, were secured using the SWC100 sensor wire clips (see figure 5 below). The 12" spacing corresponds to one sensor clip every other pale. Since the clips caused some interference with both sensor cables as installed, the SC-4 was placed in first and then the SC3-C. This caused the SC3-C to have a wavy appearance as it had to bend over previously installed sensor wire clips; however, it was determined that there was still sufficient mechanical coupling of the SC3-C to the fence to conduct testing.

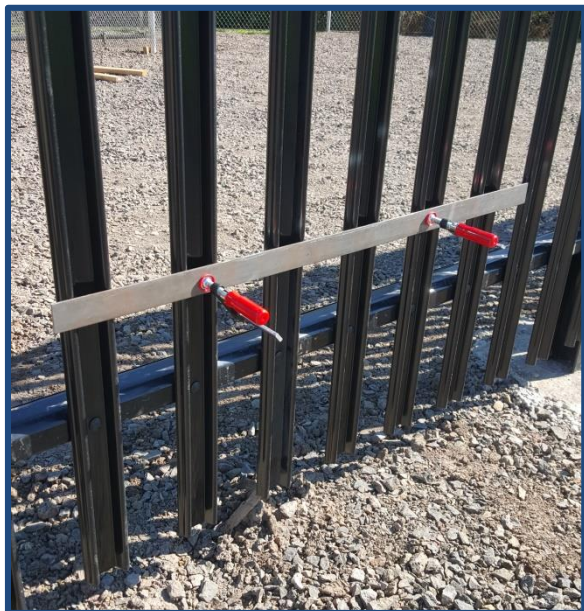
Figure 8: Non-Destructive Saw Intrusion Simulation

To simulate the act of sawing through the fence a flat piece of steel was fastened to the pales of the fence using vise clamps as shown in Figure 8 to the left.

After the steel plate was secured a threaded rod (for example ¼"-20) approximately 8" in length was dragged back and forth across it for five or more seconds.
